INDOOR AIR QUALITY ASSESSMENT

**Virginia Blanchard Elementary School
65 East Hartford Street
Uxbridge, Massachusetts**

Prepared by:
Massachusetts Department of Public Health
Bureau of Environmental Health Assessment
November, 2001

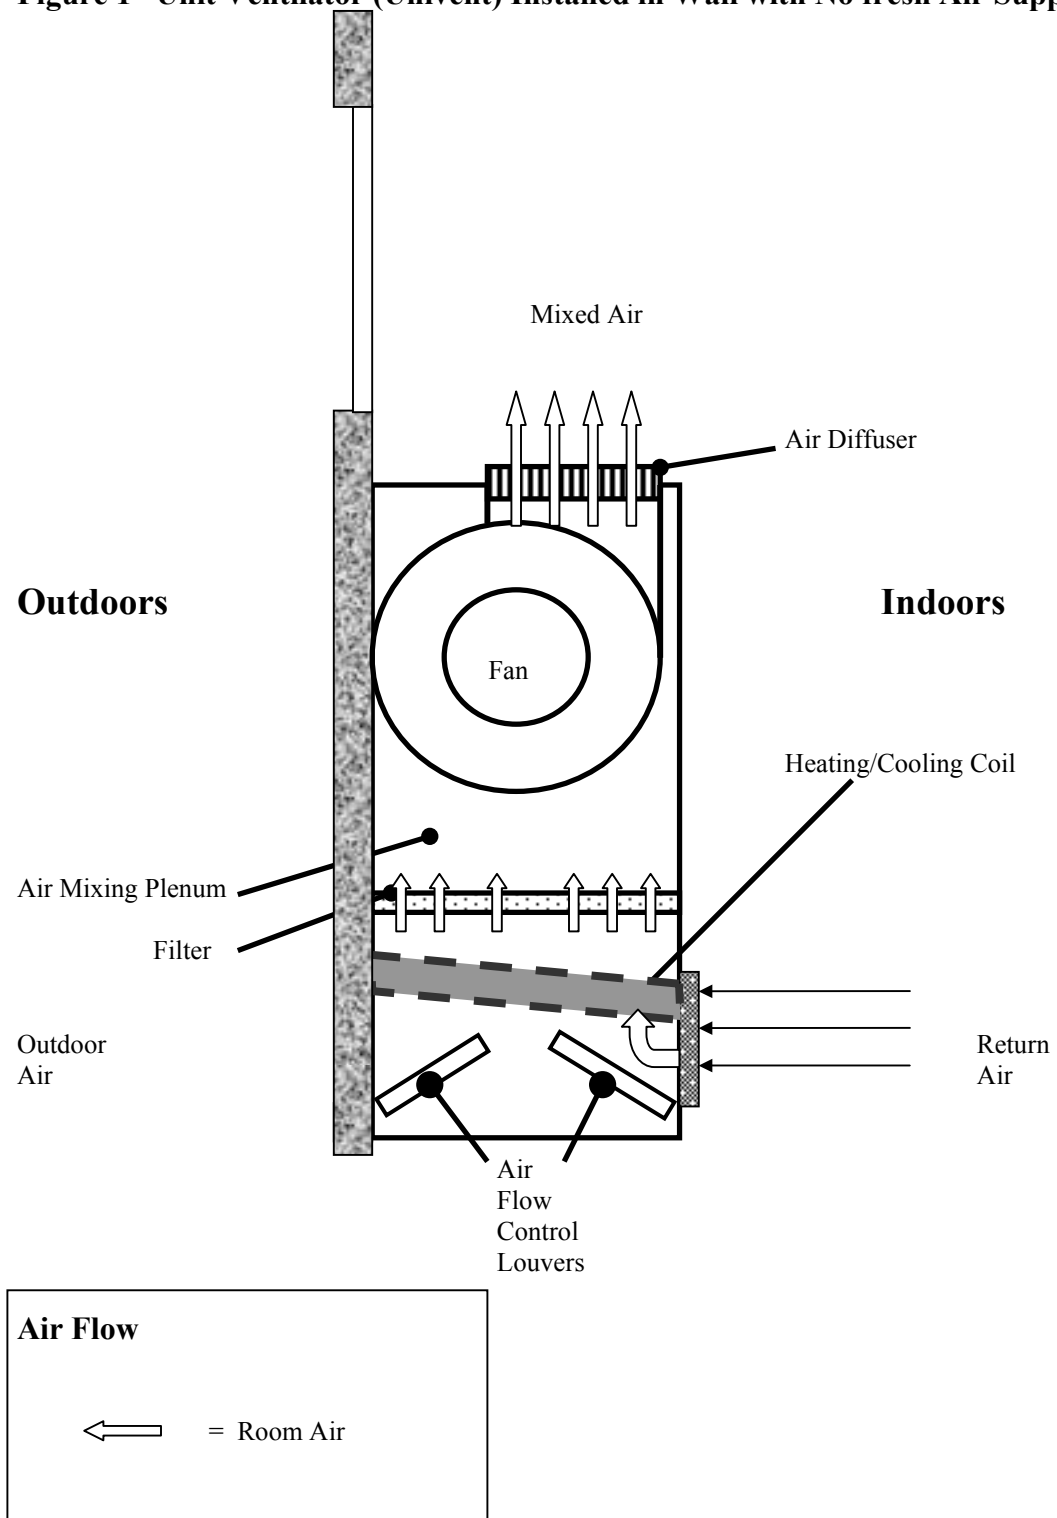
Figure 1 Unit Ventilator (Univent) Installed in Wall with No fresh Air Supply Vent

of each univent to windows found no fresh air intakes (with the exception of room 001). Therefore, the purpose of each of these univents is to provide heat only. The sole source of fresh air that exists in this building is through open windows.

2. Consult a ventilation engineer to determine whether existing univents can be retrofitted with a means to provide fresh air. If not feasible, consideration should be given to replace the existing univent system.

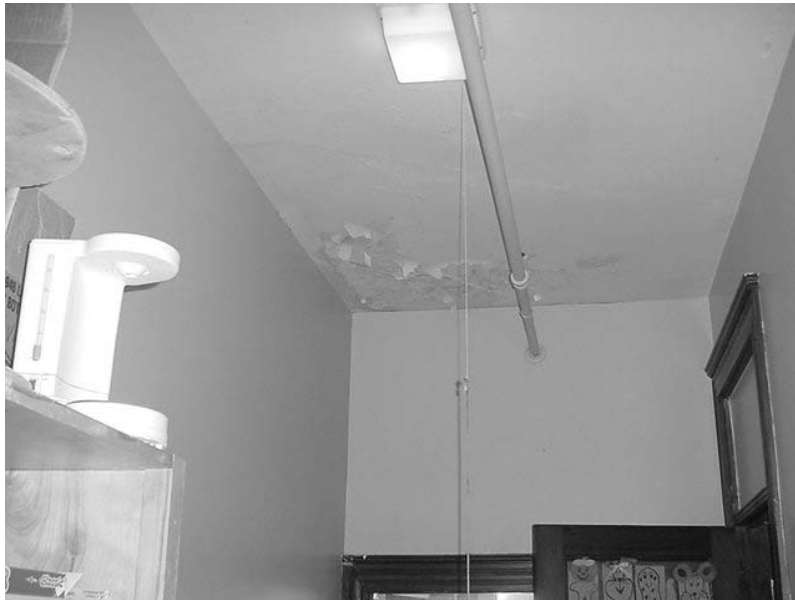
Picture 3

into the unfinished attic space, resulting in water damage to ceiling and wall plaster in the second floor restroom (see Picture 3).

Water-damaged wall plaster in the second floor rest room and the finished attic indicate that leaks through the roof system had occurred at some time prior to the assessment. Water-damaged wall plaster can, under certain circumstances, provide a medium for mold and mildew growth especially if wetted repeatedly. These materials should be repaired/replaced after a water leak is discovered and repaired.

Water Damage To Ceiling and Wall Plaster in the Second Floor Restroom

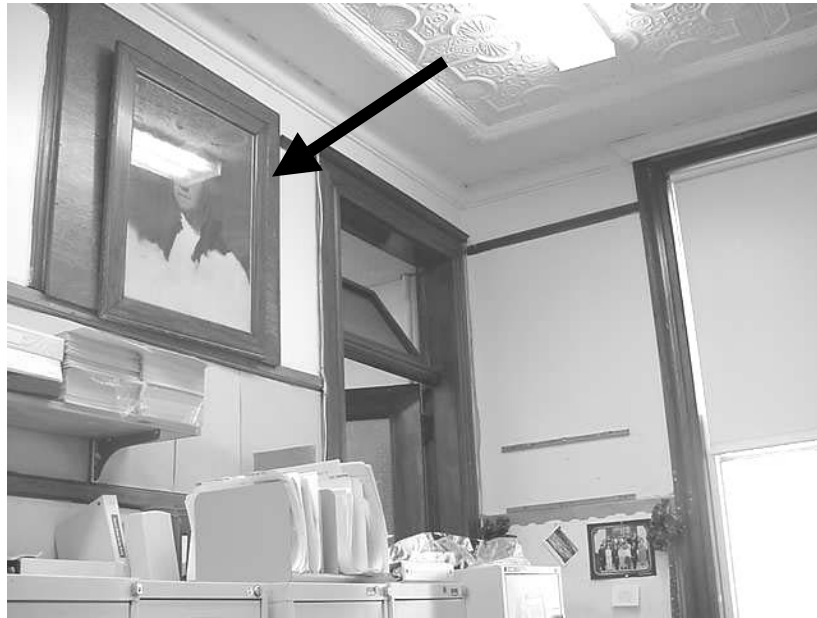
Picture 4

Original Fresh Air Supply - Sealed with Plywood

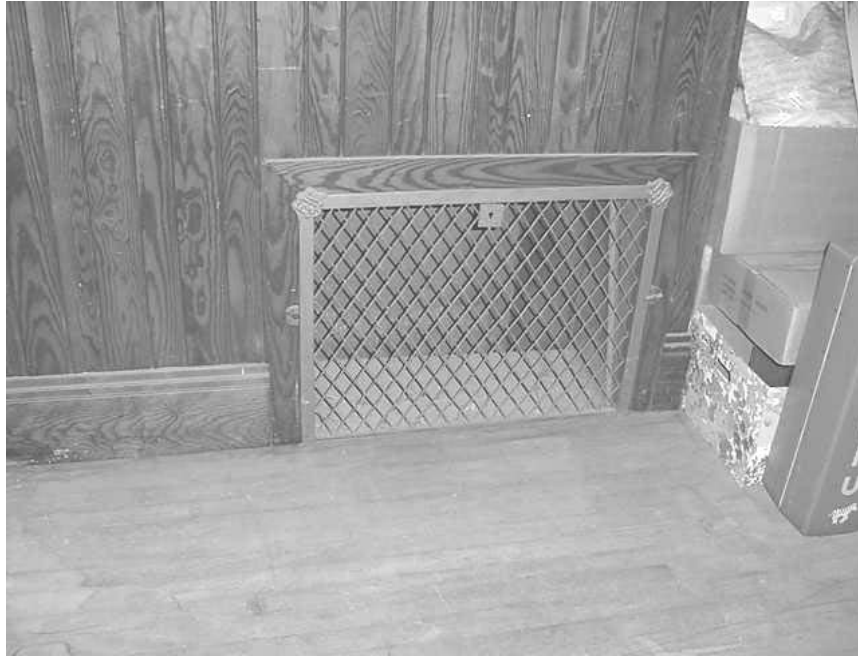
Picture 5

Exhaust ventilation is drawn from the classroom into a grated hole located at floor level (see Picture 5). No airflow was detected in any of the exhaust vents examined. A flue located inside the duct controls airflow. Above the flue is usually a heating element that creates ventilation in the same method as the fresh air supply system. These louver systems were removed during a previous renovation. The louver system was replaced with a fire damper system. The purpose of fire dampers are to prevent the spread of fire through the ventilation system by closing. Fire dampers are held in place above the duct by a chain equipped with a frangible joint. A frangible joint is made of a material that

Exhaust Vent: Note Missing Louver and Chain

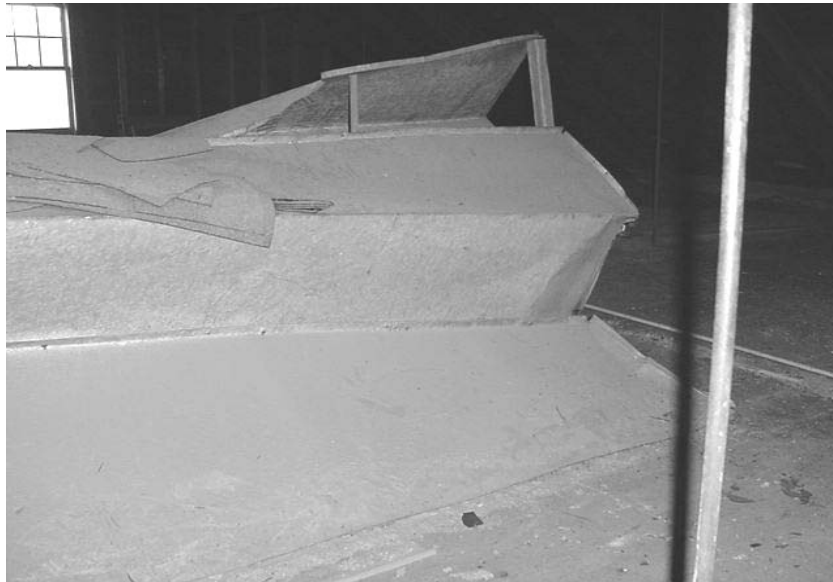
Picture 6

Crushed Ductwork in the Unfinished Attic

3. Remove debris from ducts in the unfinished attic and seal temporarily until the purpose of each duct is identified.
4. Render airtight all holes/seams in univents.

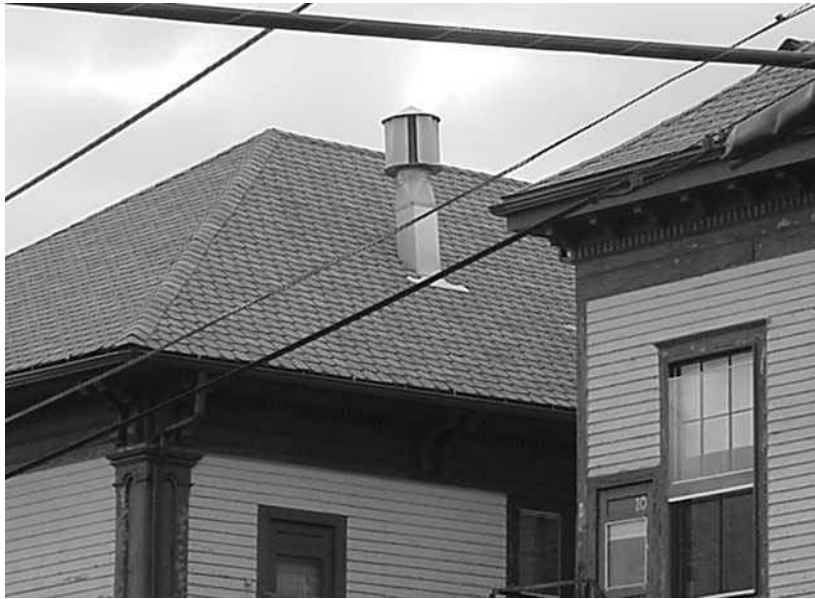
Picture 7

Exhaust Vent Terminus Exists in the Roof of the 1900 Addition

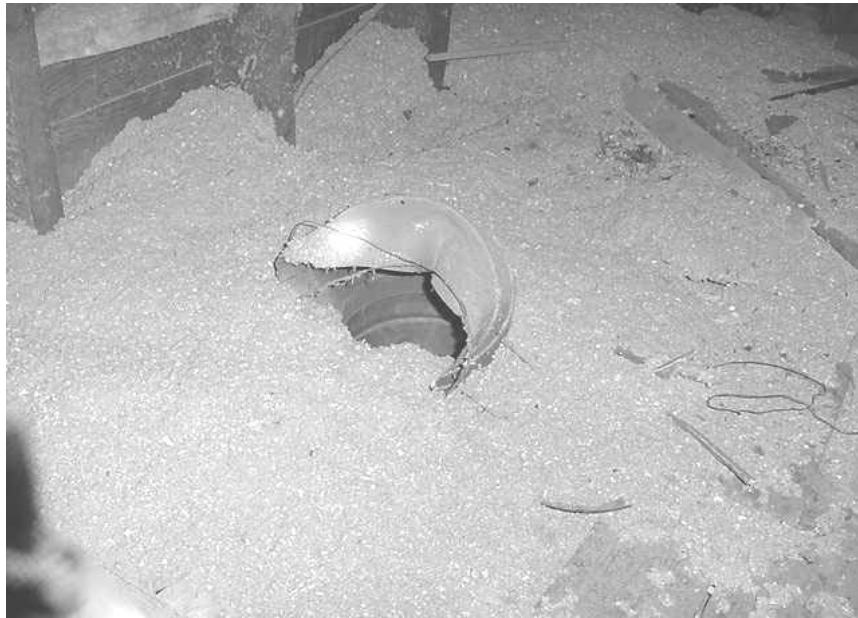
Picture 8

A Round Duct of Undetermined Purpose - Open to the Attic

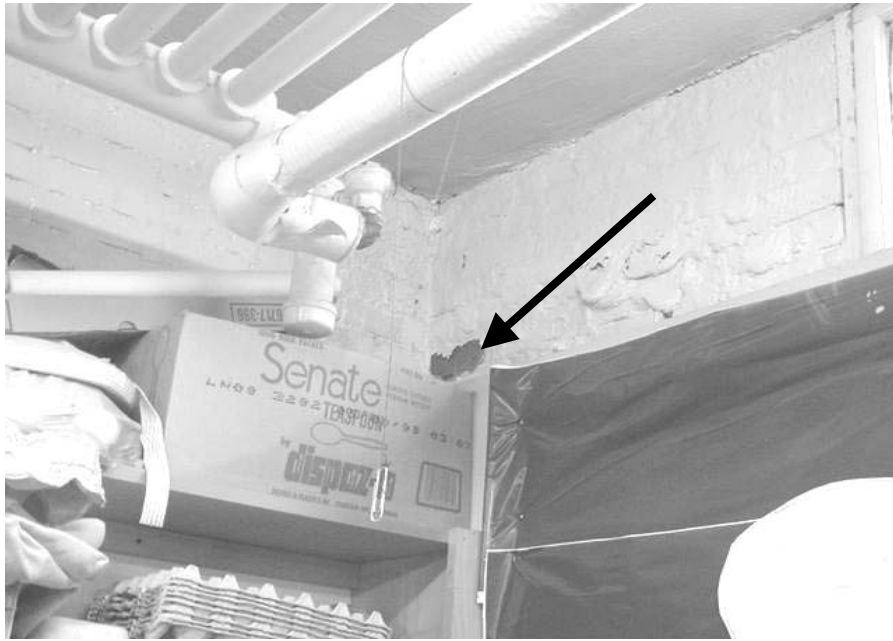
Picture 10

Damaged Brickwork on the Exterior Wall of the Cafeteria Classroom

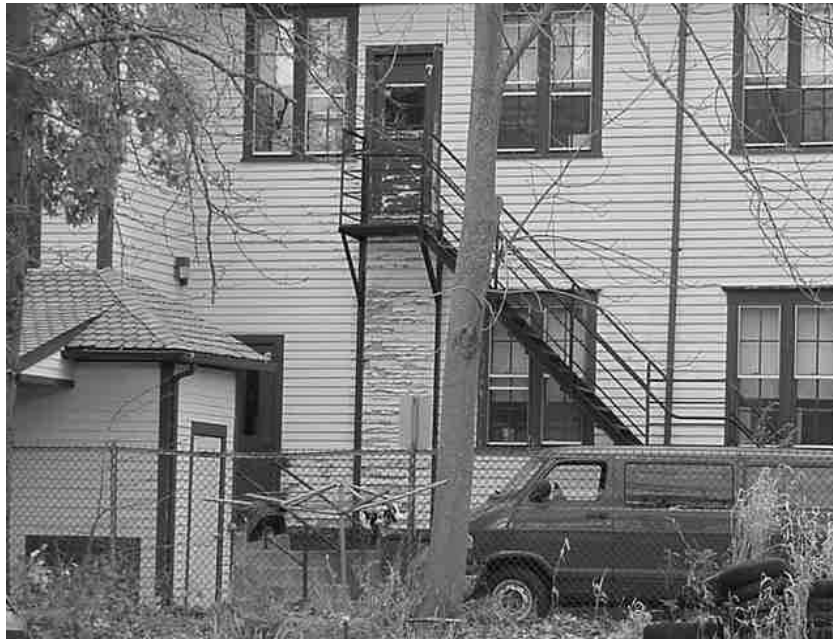
Picture 11

A number of areas on the exterior wall appear to have peeling paint and water damaged clapboard. The areas that have the most damaged paint are beneath fire escapes (see Picture 11) or possible leaking downspouts. If rain penetrates through the exterior wall system into the wall cavity, this condition may lead to microbial growth in different building systems.

Damaged Paint beneath Fire Escape

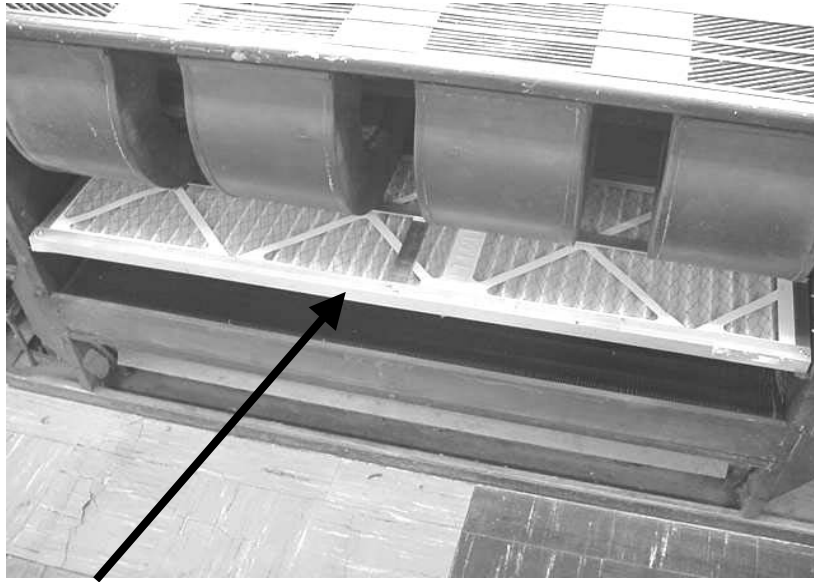
Picture 12

As originally installed, univents were not provided with a means to install filters. A consultant hired to evaluate the indoor air quality in this building retrofitted each univent with a filter system (see Picture 12). Without filters, particles can become aerosolized. In order to decrease aerosolized particulates, disposable filters with an increased dust spot efficiency can be installed. The dust spot efficiency is the ability of a filter to remove particulates of a certain diameter from air passing through the filter. Filters that have been determined by ASHRAE to meet its standard for a dust spot efficiency of a minimum of 40 percent would be sufficient to reduce airborne particulates (Thornburg, D., 2000; MEHRC, 1997; ASHRAE, 1992). Note that increased filtration can reduce airflow produced by the univent through increased resistance (called pressure drop). Prior to any increase of filtration, univents should be evaluated by a ventilation engineer to ascertain whether they can maintain function with more efficient filters.

Retrofitted Filter System in Univent

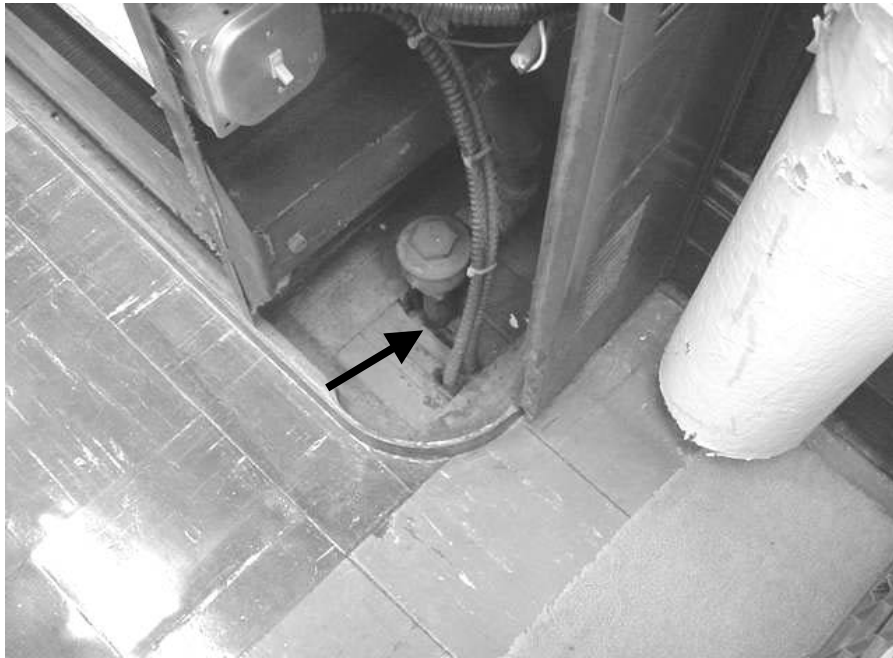
Picture 13

Spaces around pipes were noted within all univent cabinet interiors surveyed (see Picture 13). Open pipes and spaces around pipes can serve as pathways for dust, dirt, odors and other pollutants to move from the floor/wall cavities into occupied areas during the operation of univents.

Spaces Around Pipes – Observed Within All Univent Cabinet Interiors
